**INTEGRATED PROPULSION CONTROL SYSTEM (IPCS)  
FINAL REPORT  
VOLUME III  
FLIGHT TEST REPORT**

**BOEING AEROSPACE COMPANY  
P.O. BOX 3999  
SEATTLE, WA. 98124**

**AUGUST 1976**

**TECHNICAL REPORT AFAPL-TR-76-61 VOLUME III  
FINAL REPORT FOR PERIOD 1 MARCH 1973 - 30 AUGUST 1976**

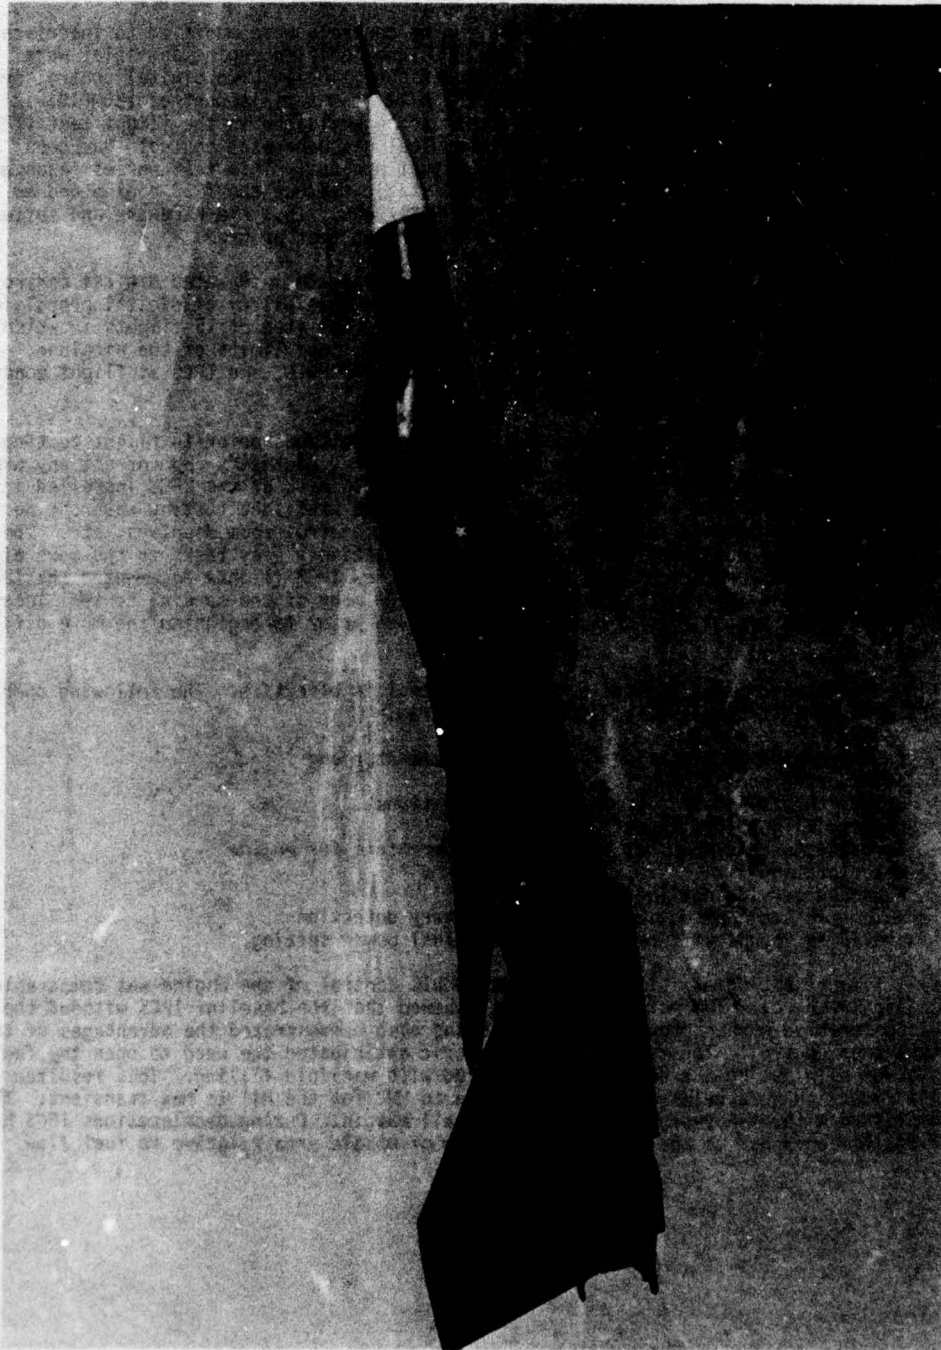
Figure 1.0-1 F-111 Test Airplane

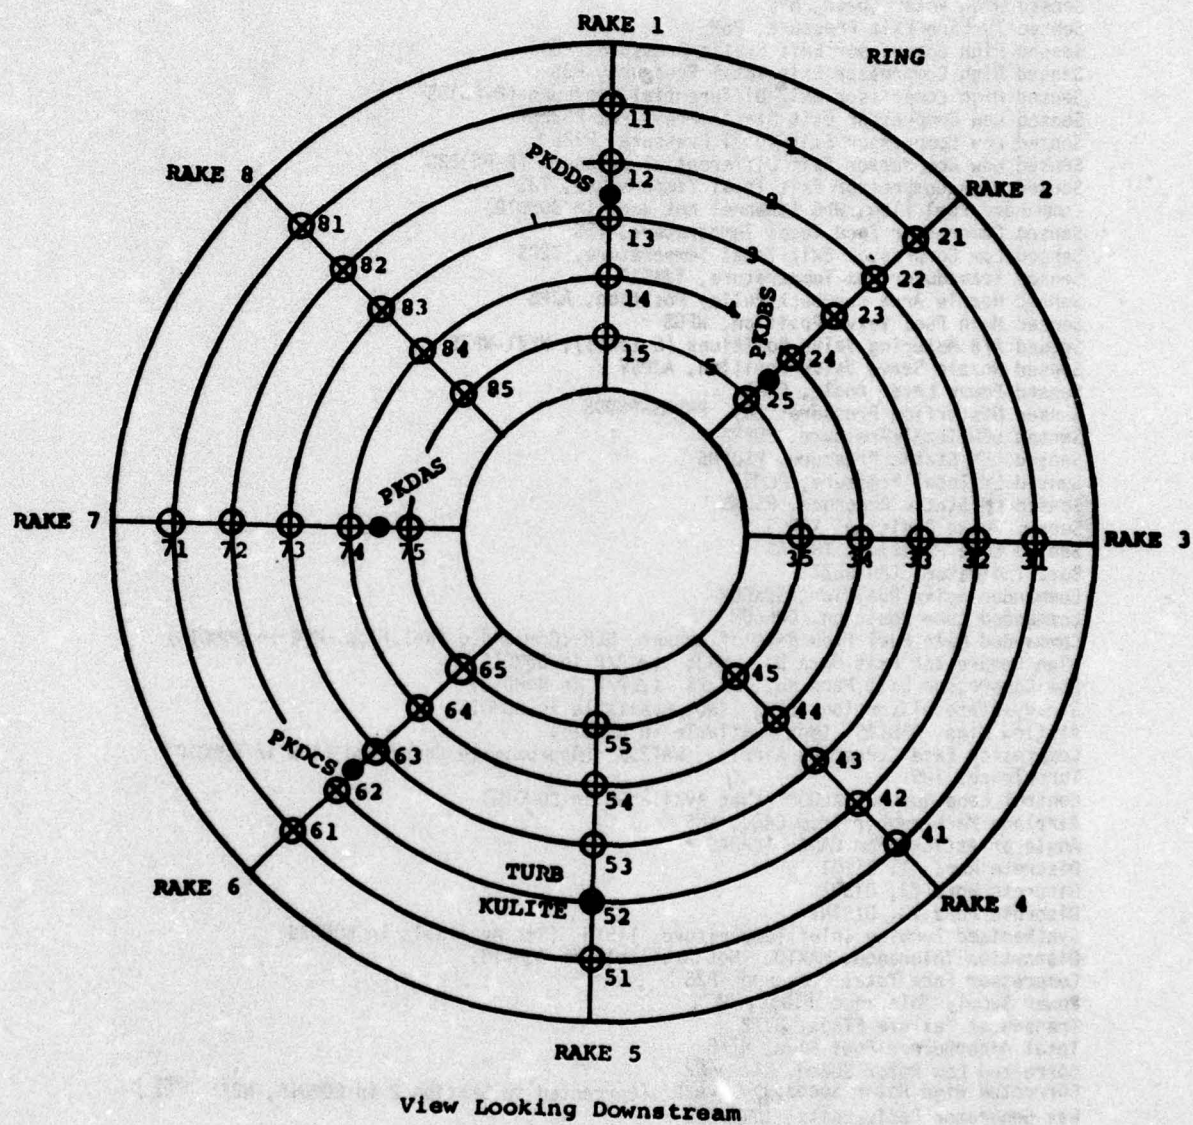
Figure 5.1-1 Compressor Face Distortion Rake

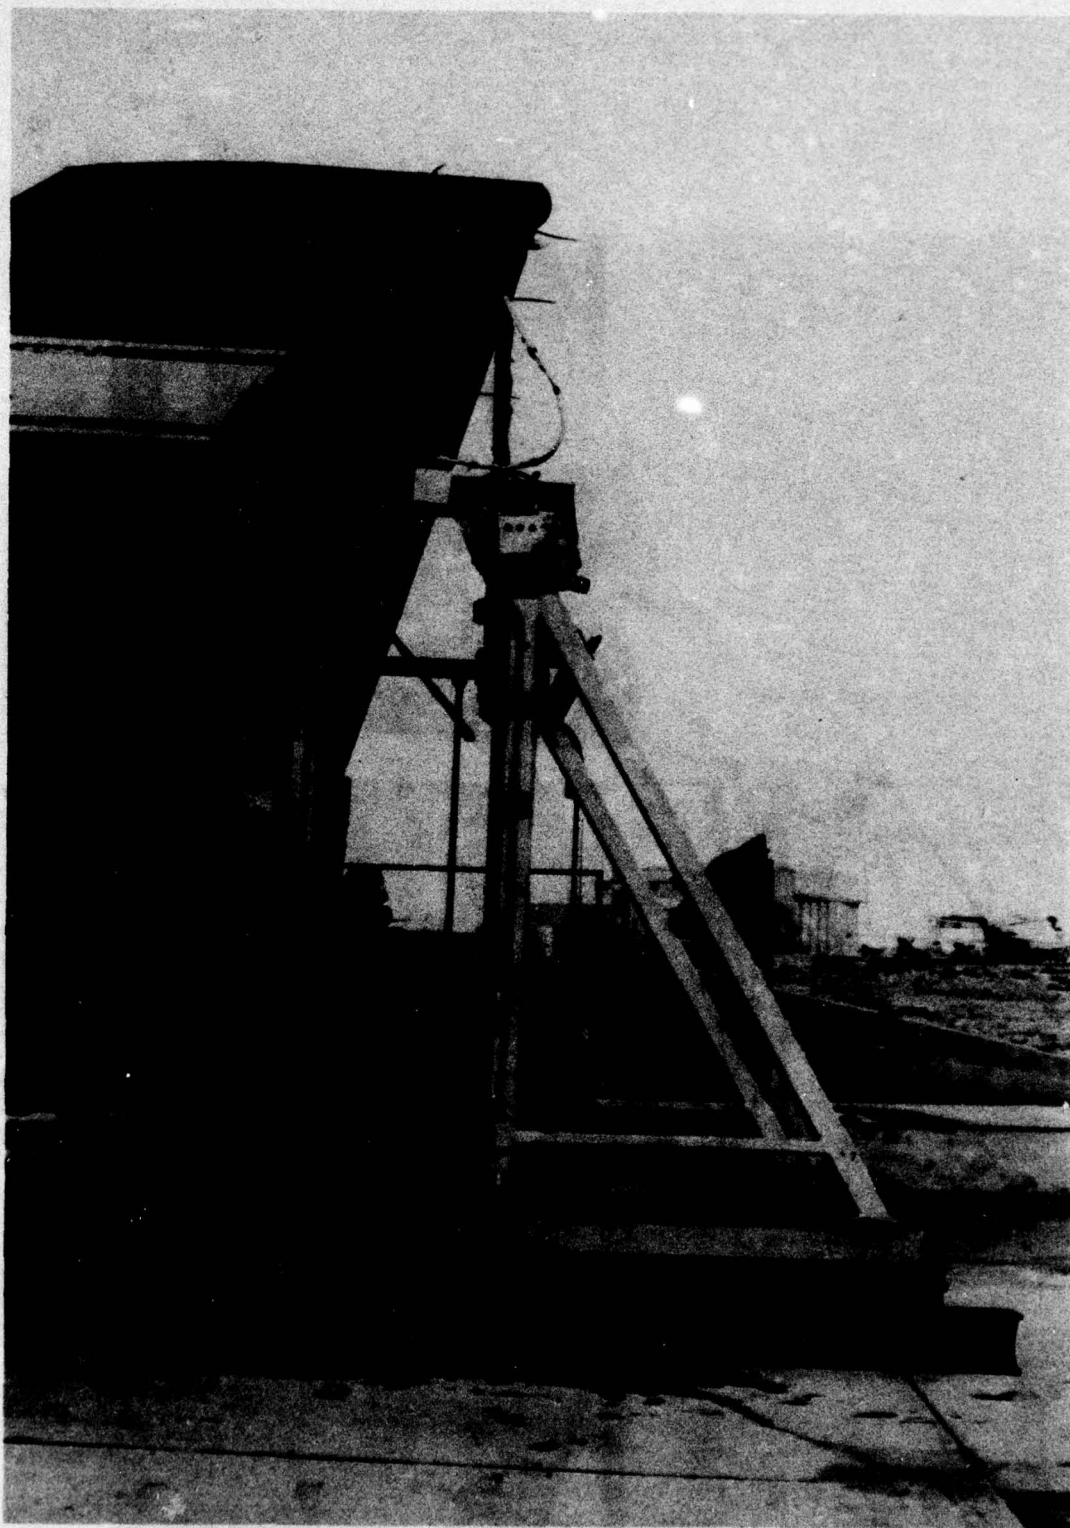
Figure 5.1-3 Side View of Exhaust Profile Rake Installation

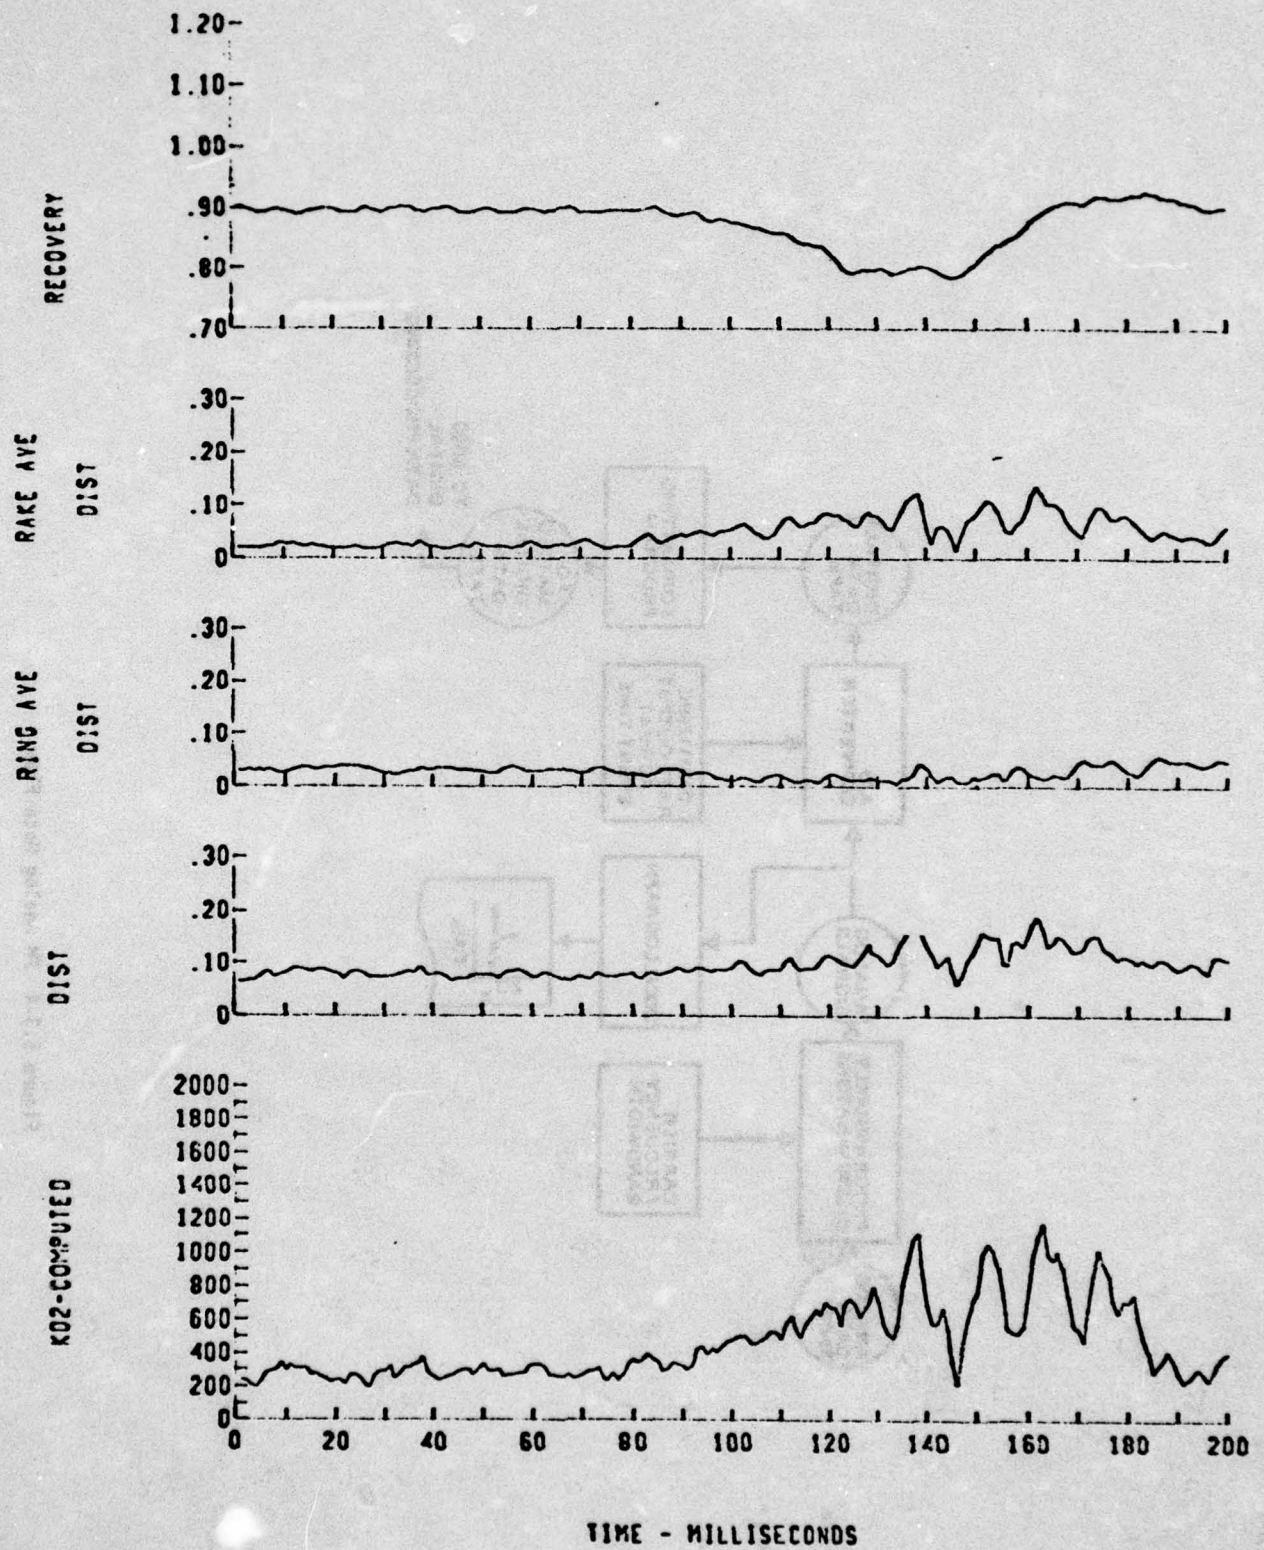
Figure 5.3-5 Typical Distortion Time Histories

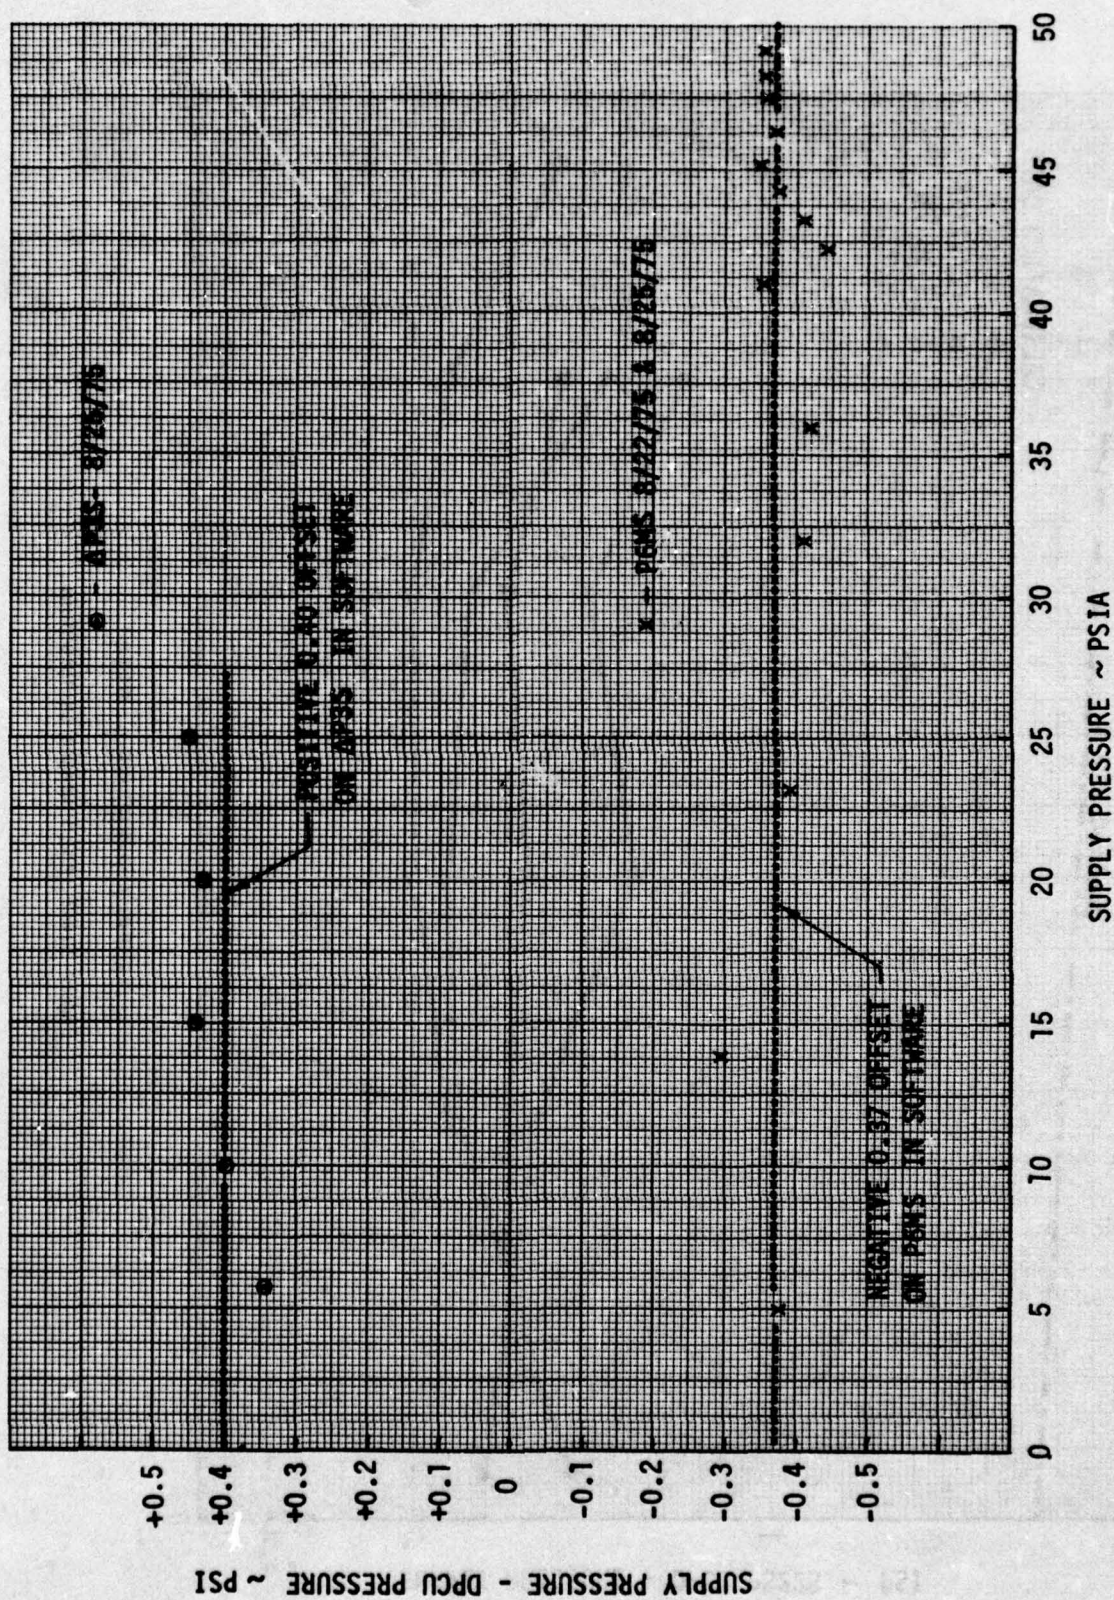
Figure 5.4-1 P6MS and AP3S Preflight Transducer Calibrations

The only significant pressure signal noise which was experienced during the flight test program was that exhibited by the  $\Delta$ P3S pressure measurement. As discussed in paragraph 5.4.4 the noise level of the absolute pressure measurements, P3S and PS3S is insignificant; however, the  $\Delta$ P3S

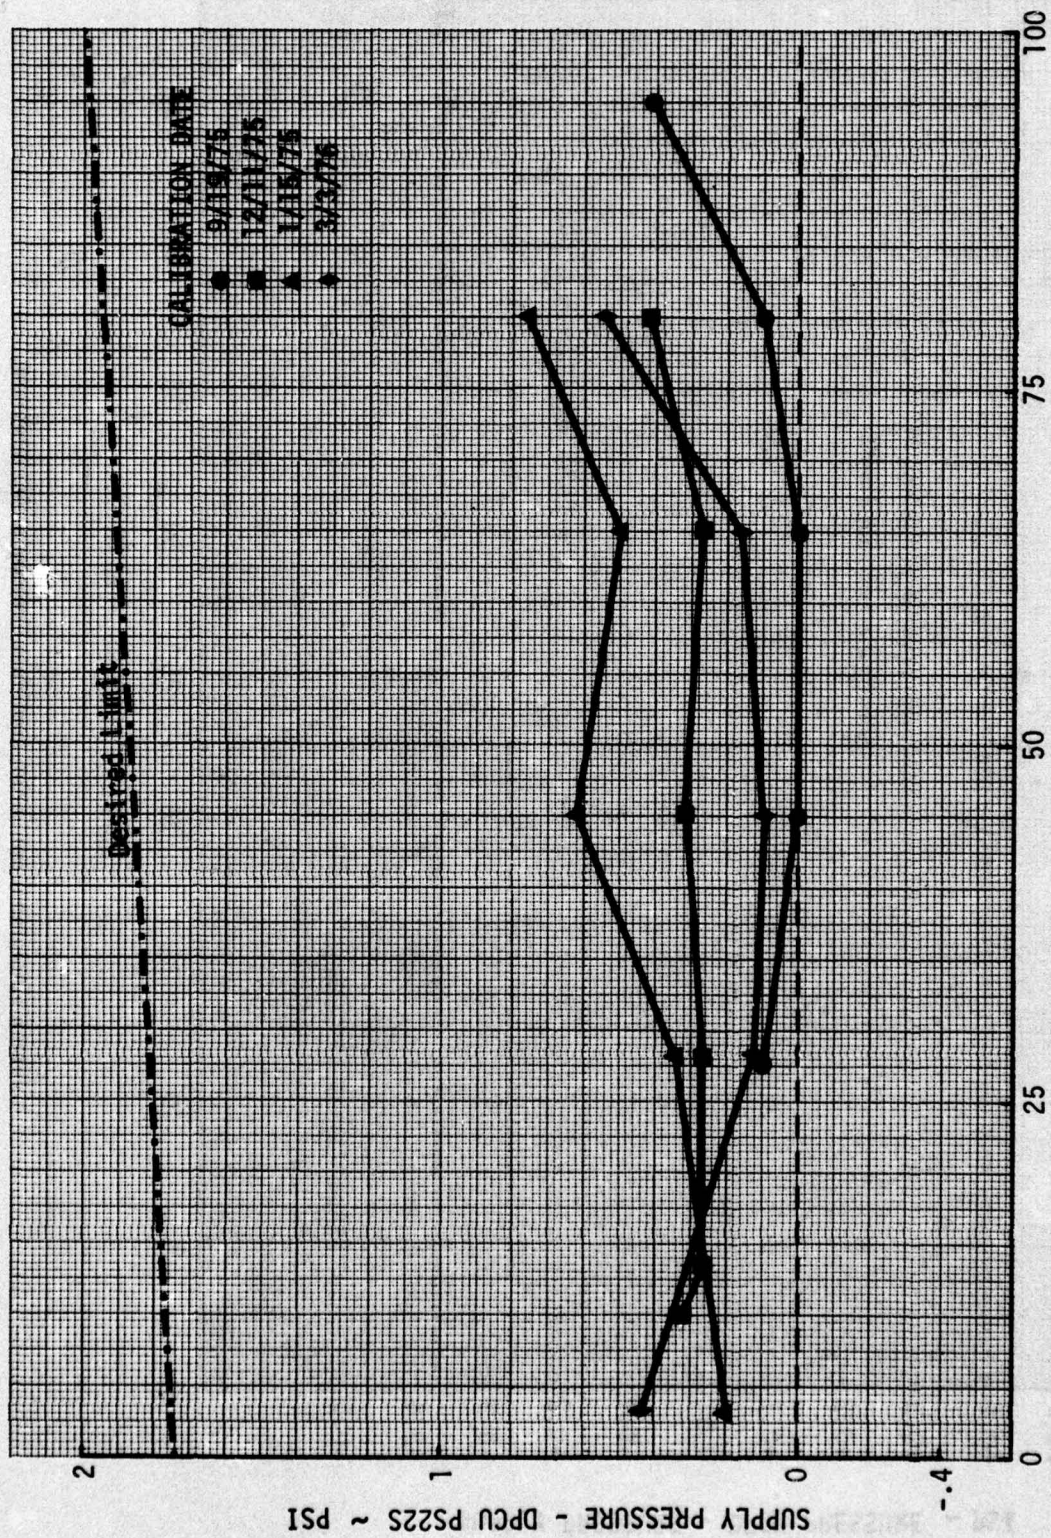
Figure 5.4-2 PS225 Ground Calibrations

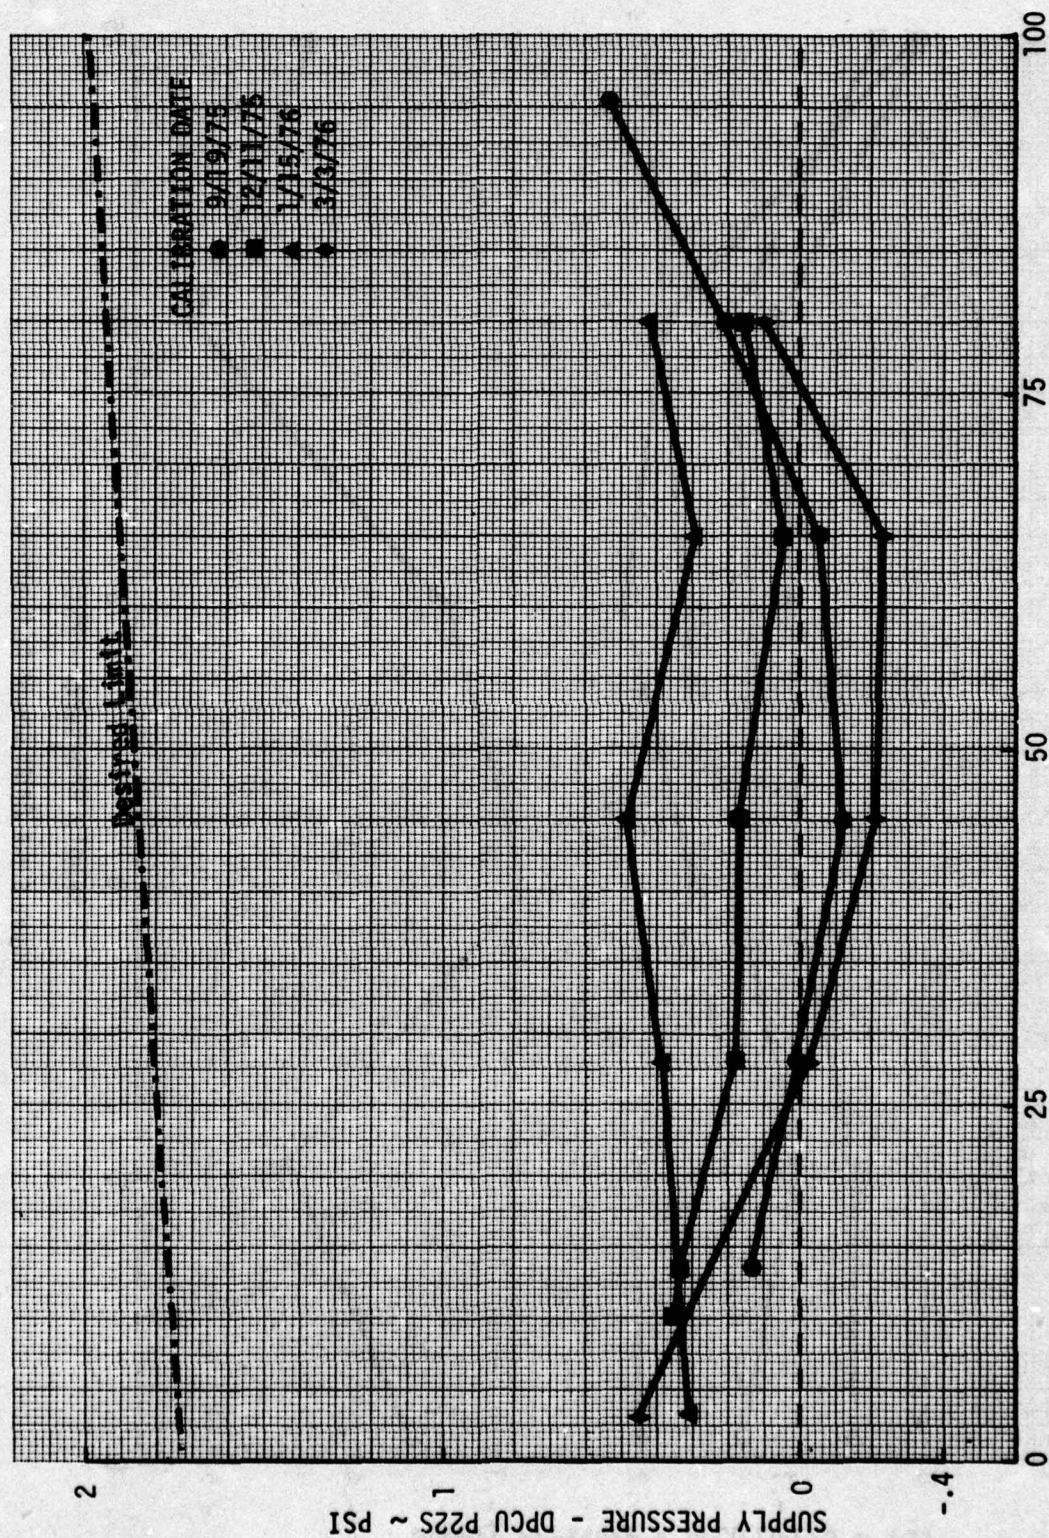
SUPPLY PRESSURE ~ PSIA  
Figure 5.4-3 P225 Ground Calibrations

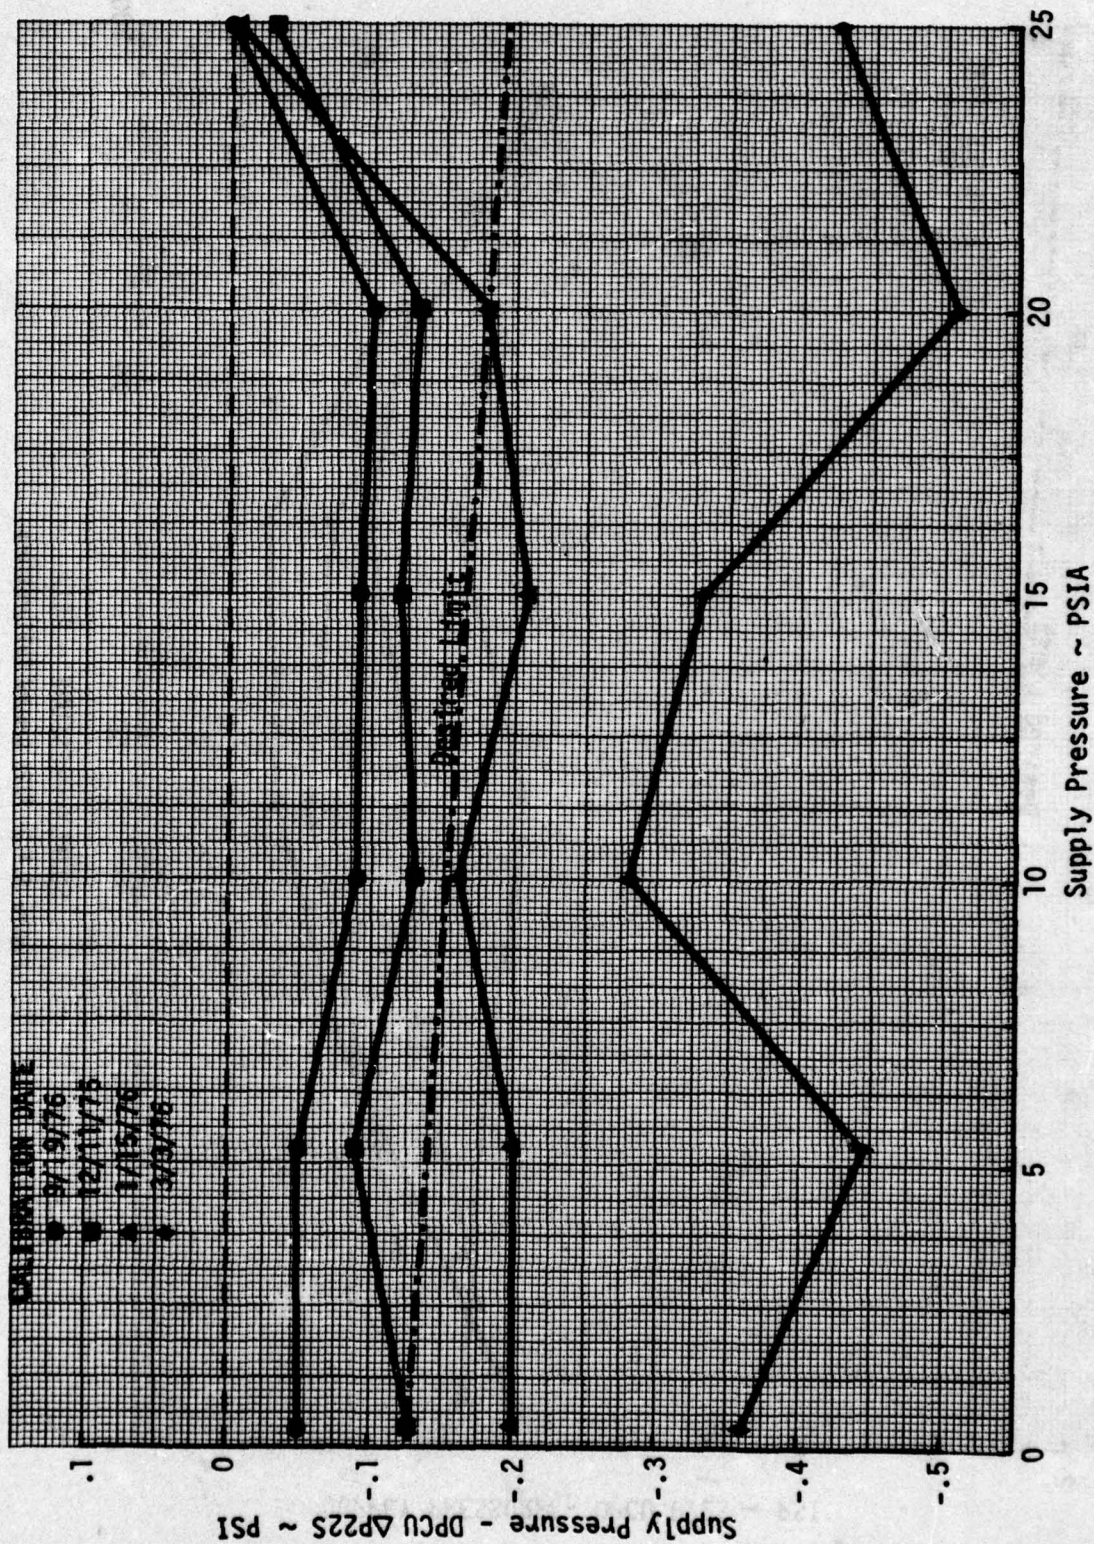
Figure 5.4-4  $\Delta$ P225 Ground Calibrations

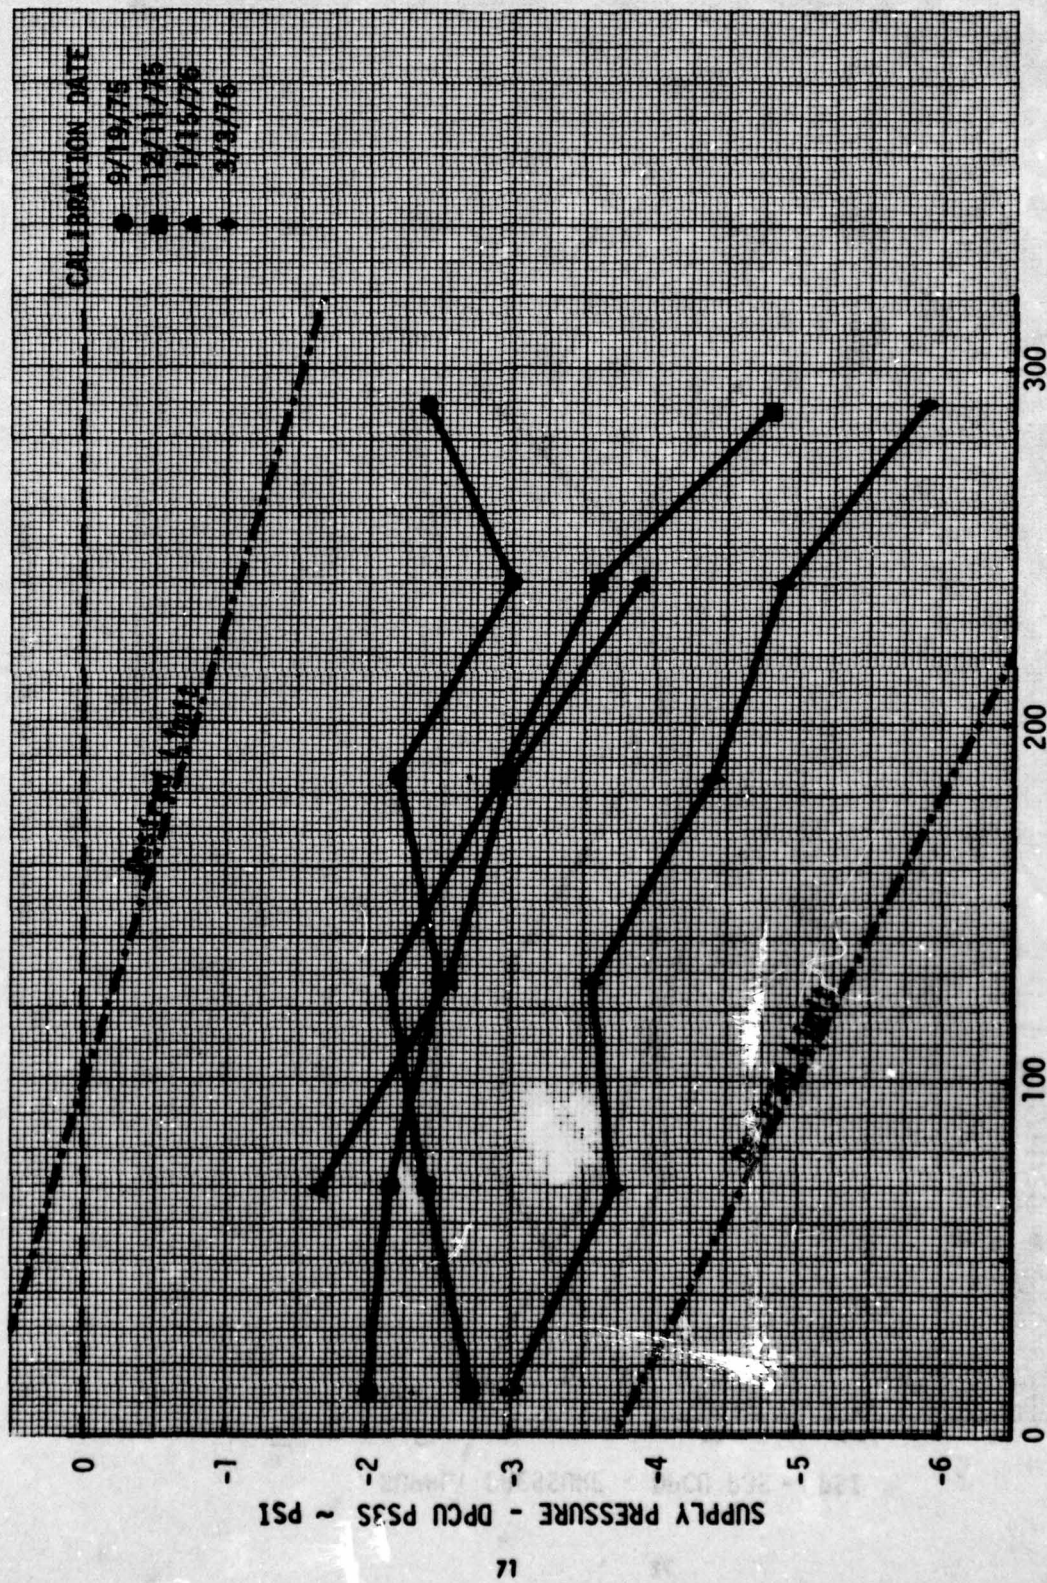
Figure 5.4-5 PS3S Ground Calibrations

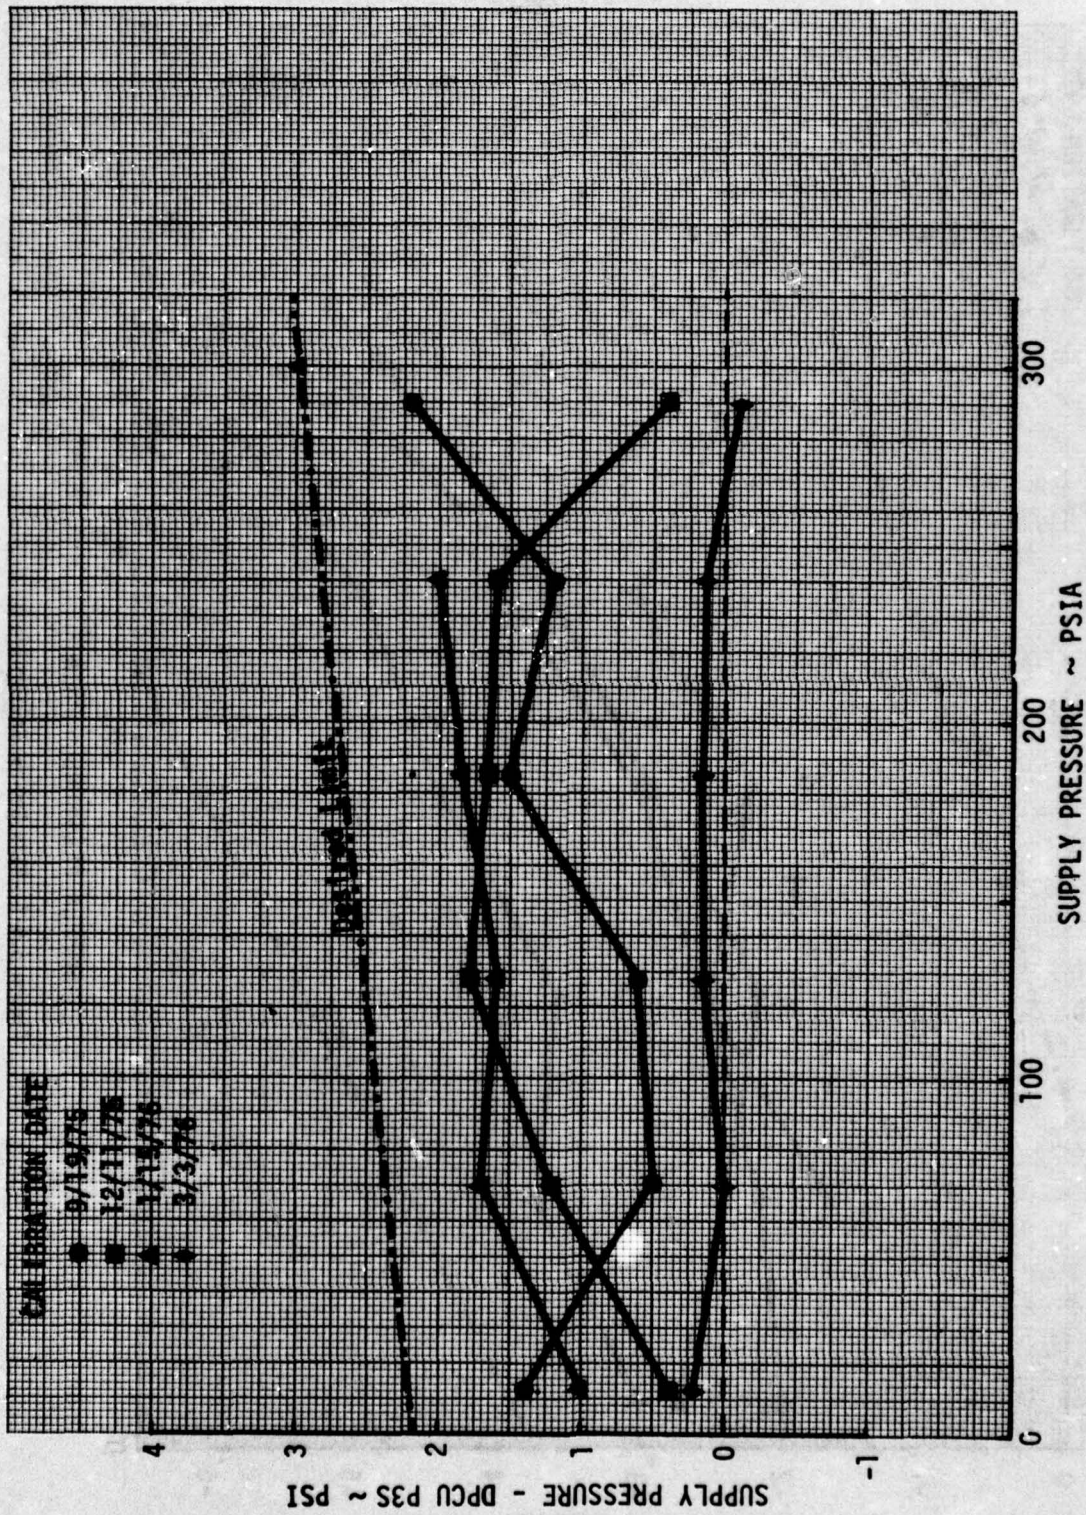
Figure 5.4-6 P3S Ground Calibrations

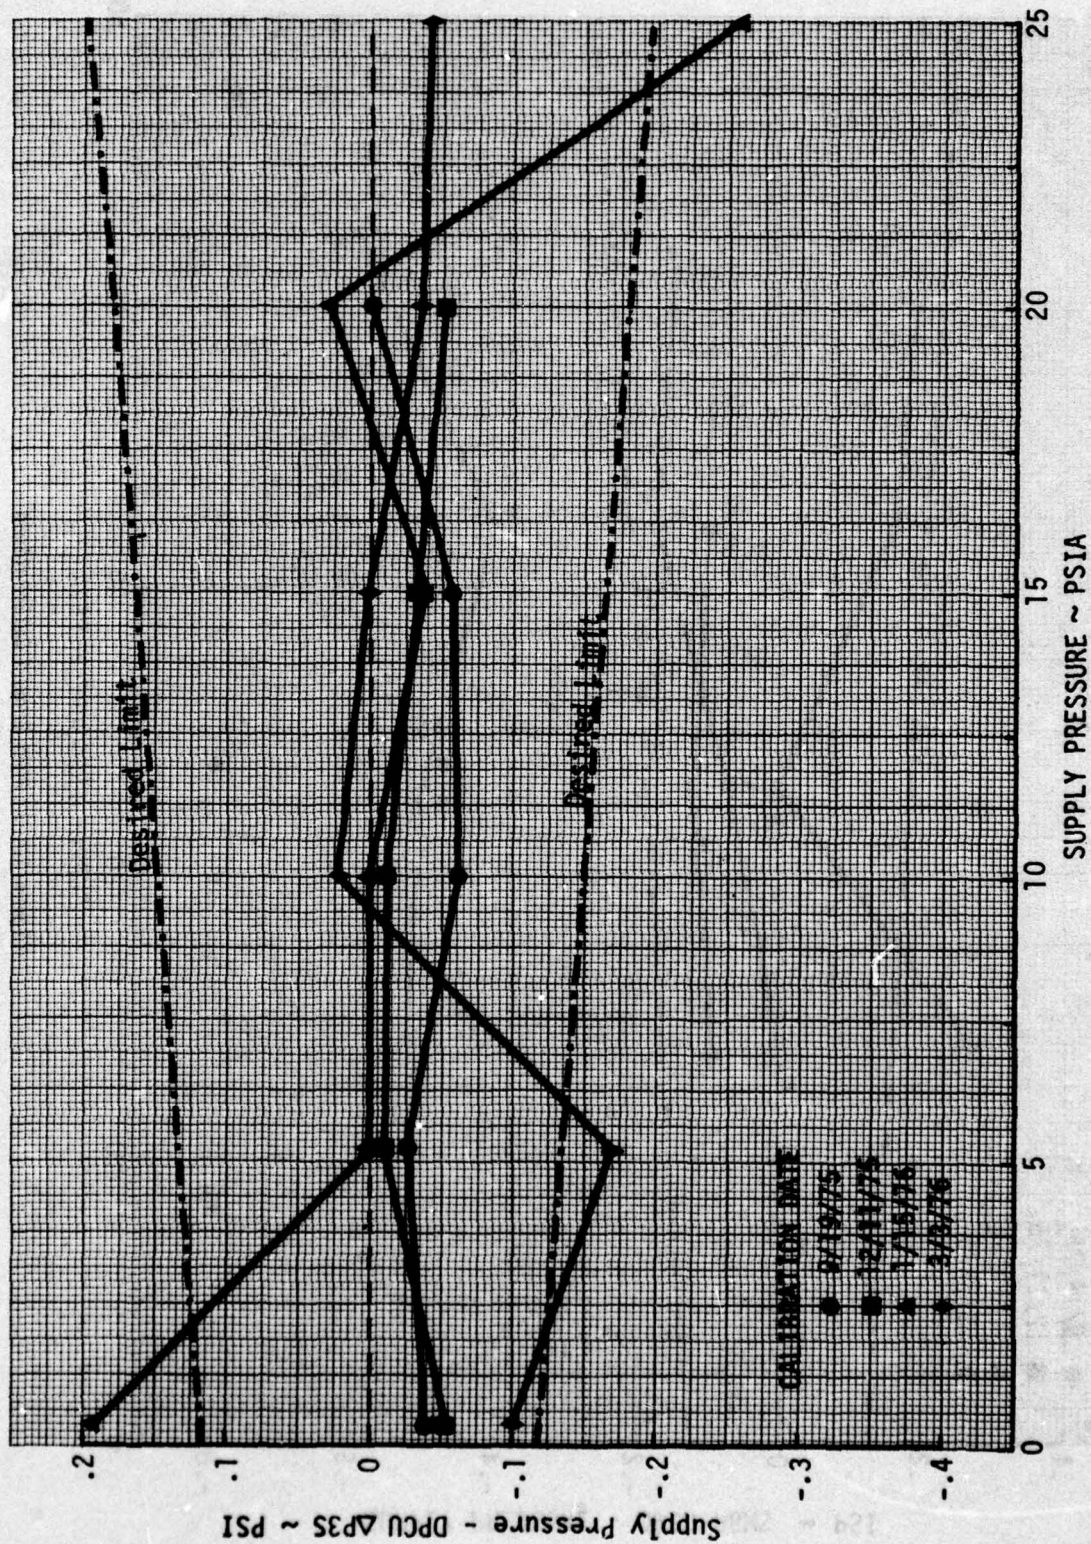
Figure 5.4-7 ΔP35 Ground Calibrations

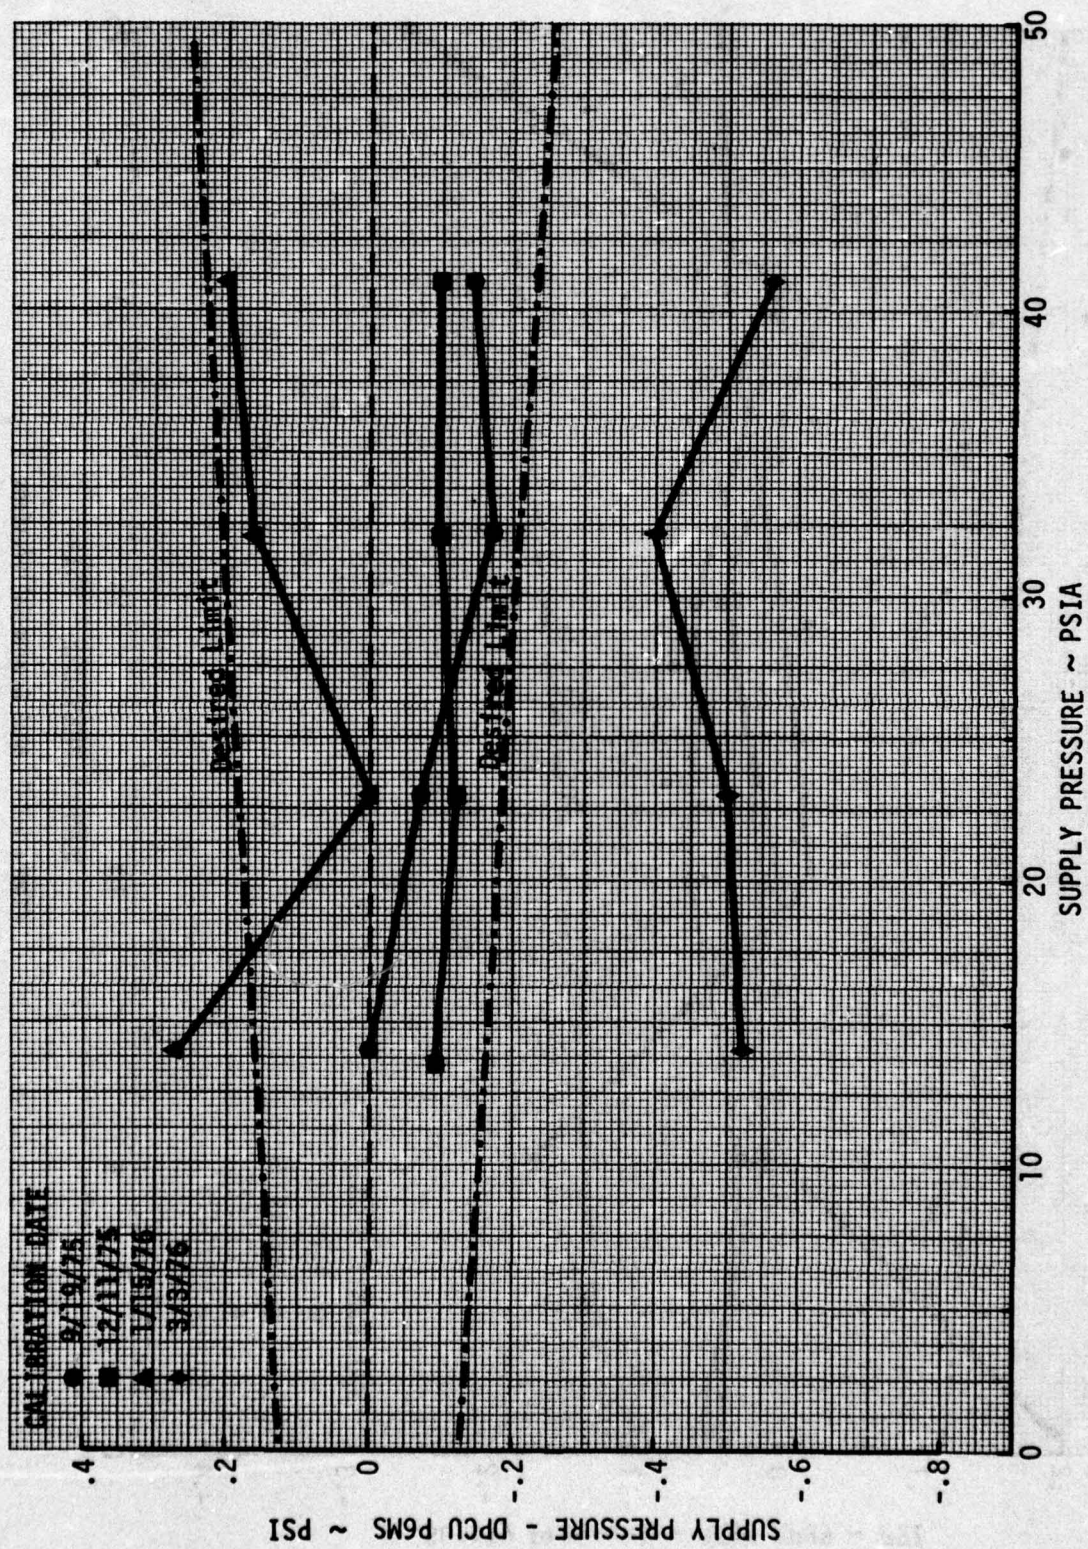
Figure 5.4-8 P6MS Ground Calibrations

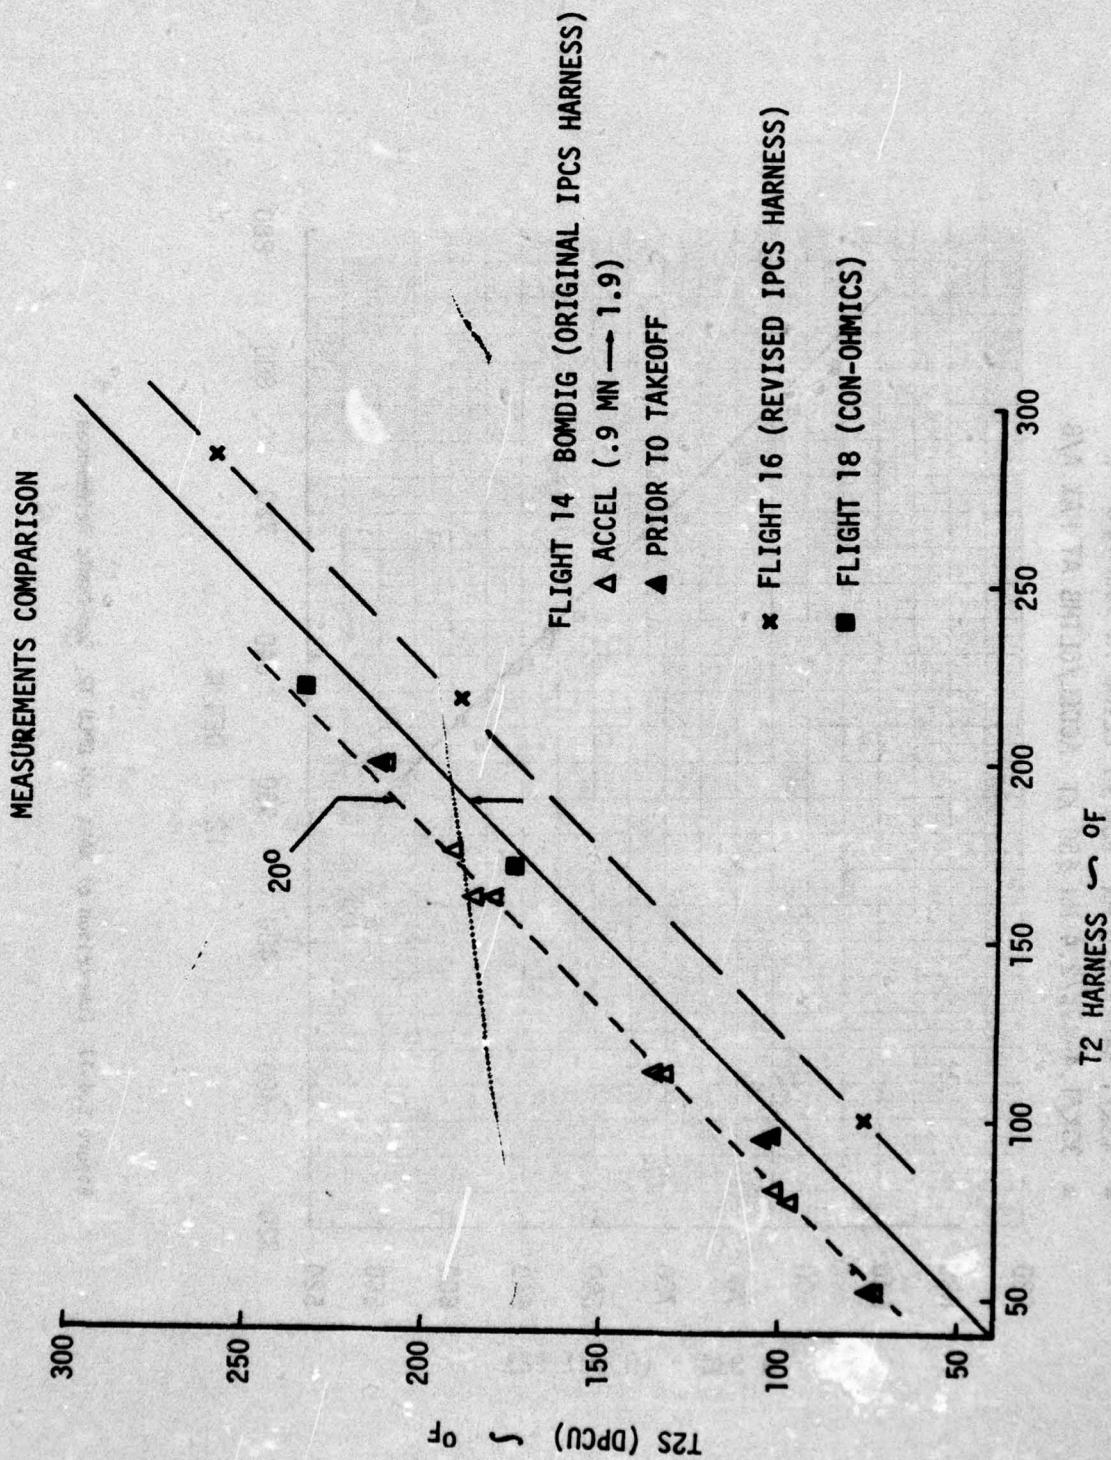
Figure 5.4-16 Comparison of NASA and DPCU T2, IPCS Harness

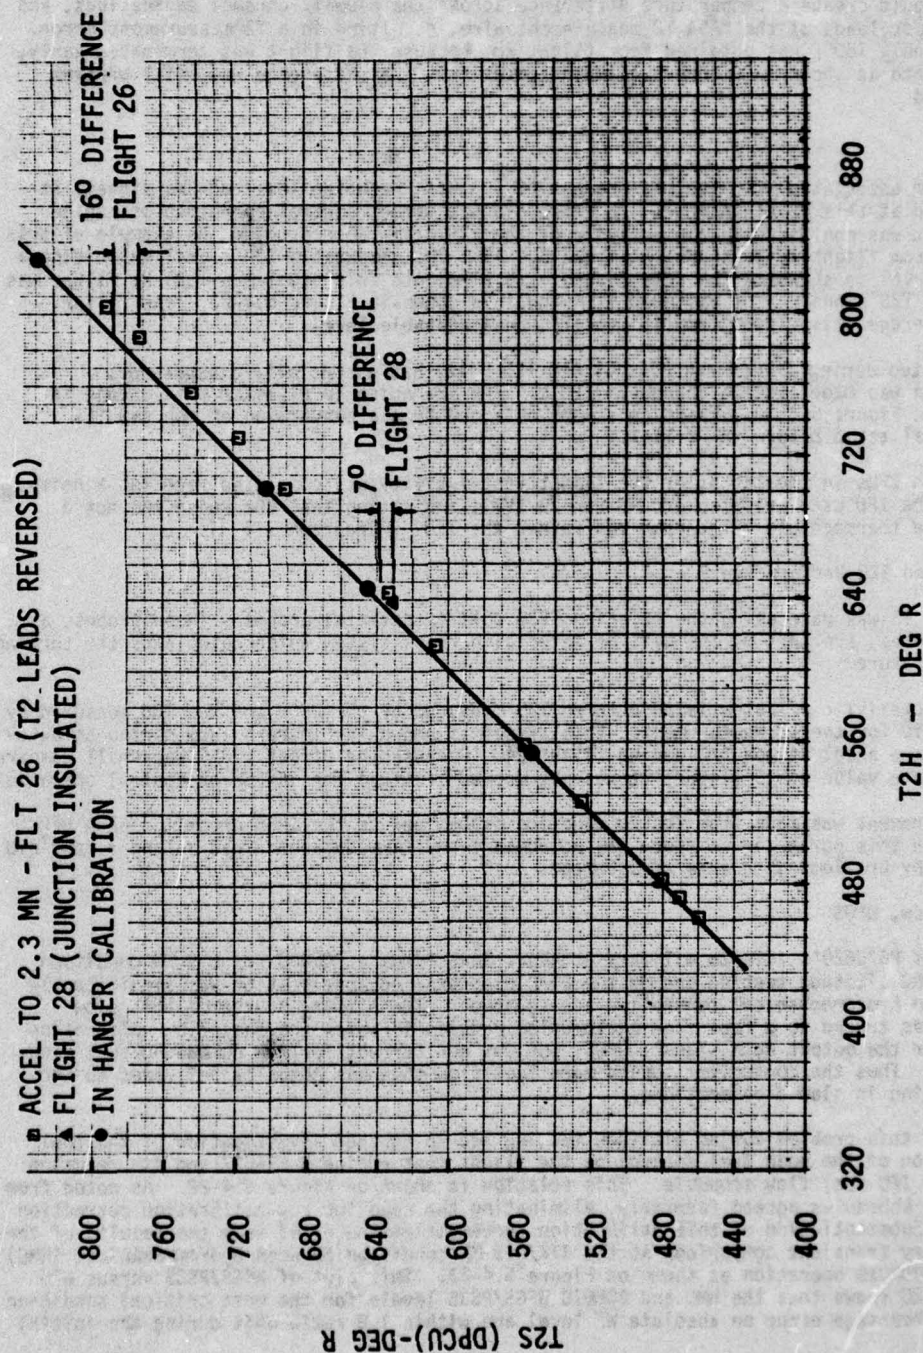
Figure 5.4-18 Comparison of NASA and DPCU T2, Hanger and flights 26 and 28

An in-hangar static calibration was performed by applying heat to the T2 probe from 90°F to 360°F and measuring the output of the NASA T2 and T2S. The results of this calibration, as noted on Figure 5.4-18 show that the two measuring systems are in complete agreement, implying that the T2 offset is a flight-oriented problem.
